Manhole Inspection Summary

Manhole # S350__040MH

Insp Date: **3/19/08 2:02 PM**

Location Address: **36 s charles**

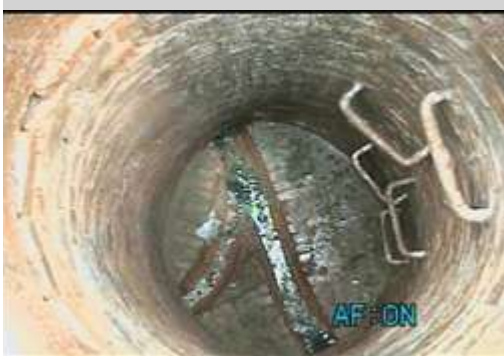
Defect 1

Condition: ☐ Sound ☐ Cracked ☐ Root Intrusion ☒ **Loose Brick** ☐ Deteriorated

Steps Count: **5** Missing: **0** ☒ **Corroded**

corroded steps, loose bricks

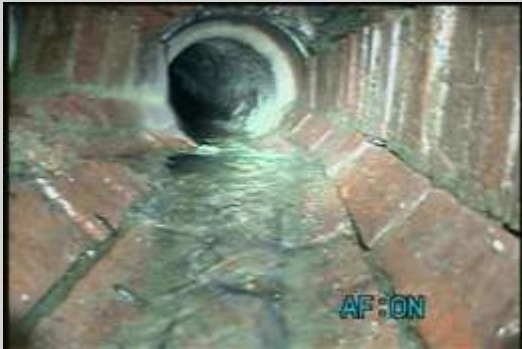
12 O'Clock Outflow

8 in. Circular Gravity Sewer
Pipe Out @ 12 O'Clock

Pipe Material: **Clay** ☐ Pipe Lined

Invert Depth: **9.90** (ft.) Flow Characteristics: **Slow**

Infiltration: **None** Pipe Seal Cond: **Unknown**

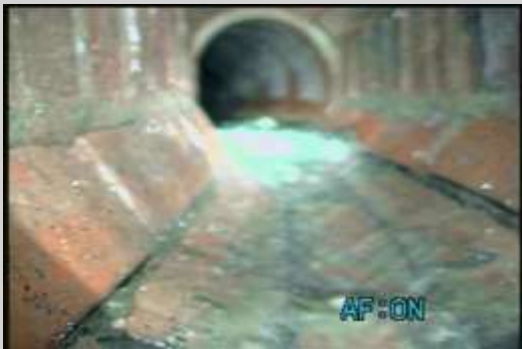
6 O'Clock Inflow

8 in. Circular Gravity Sewer
Pipe In @ 6 O'Clock

Pipe Material: **Clay** ☐ Pipe Lined

Invert Depth: **9.20** (ft.) Flow Characteristics: **Slow**

Infiltration: **None** Pipe Seal Cond: **Unknown**

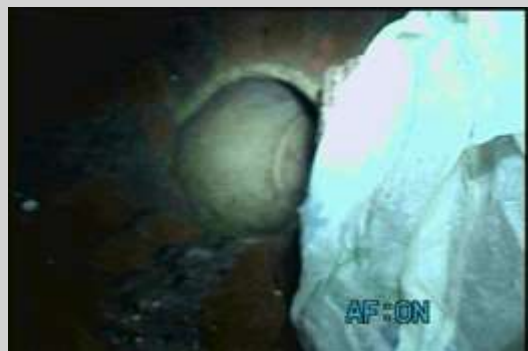
9 O'Clock Inflow

8 in. Circular Gravity Sewer

Pipe In @ 9 O'Clock

Pipe Material: **Clay** ☐ Pipe Lined

Invert Depth: **9.00** (ft.) Flow Characteristics: **Slow**

Infiltration: **None** Pipe Seal Cond: **Unknown**
